**Ace Inspectors**  
 Tx License 8796  
 208 Montego Bay  
 El Paso, Tx 79912  
 Tel (195) 539 3096

Date: 26 Jan 06      Week 04  
 Time: 12:45 p.m.  
 Temp. 69° F  
 Weather: Good - 28% rel. hum.

Site Report No. **Client 26 Jan 06**  
 Owner: Client's Name  
 Address: Client's Address  
 Report By: Inspector's Name

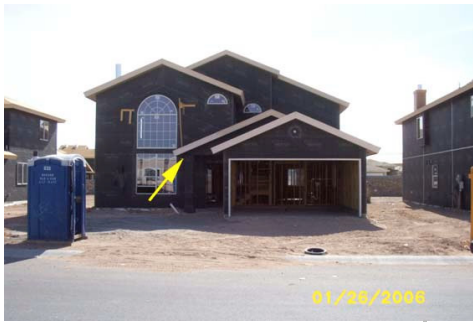
Looking south @ front of house – note arrow indicates missing stucco lathe (mesh) **1**

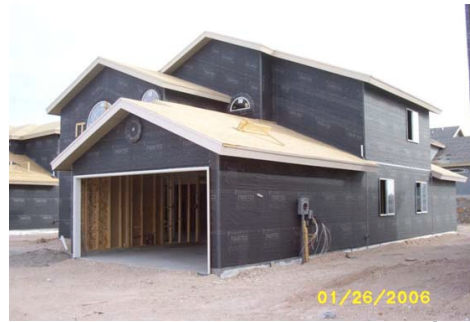
Looking south east @ west side of house **2**

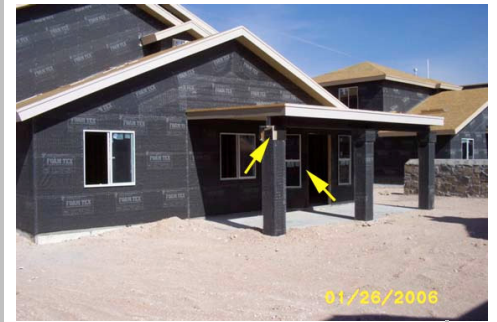
Looking north east @ rear of house – arrows indicate missing column caps and indicates missing stucco lathe **3**

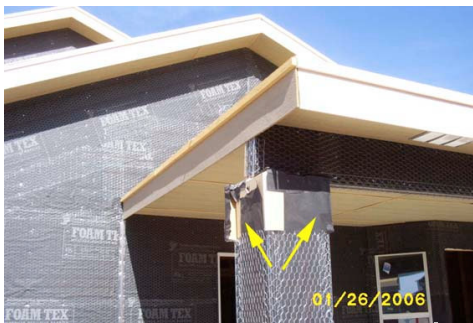
Looking north east @ close up of missing column caps **4**

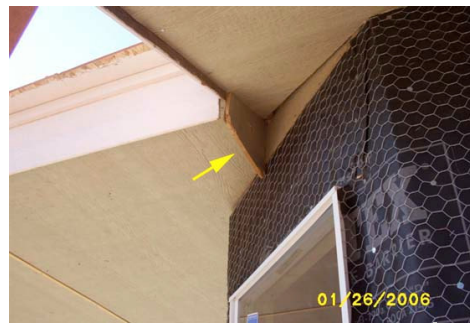
Looking southwest @ east side porch transition to house – note problematic transition **5**

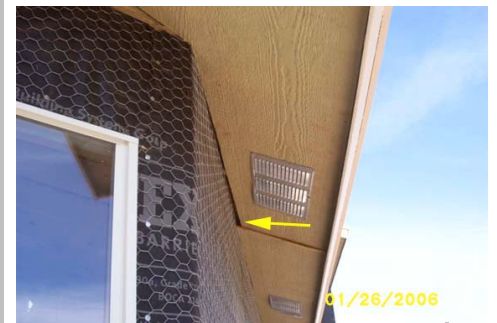
Looking north @ gap along east side soffit **6**

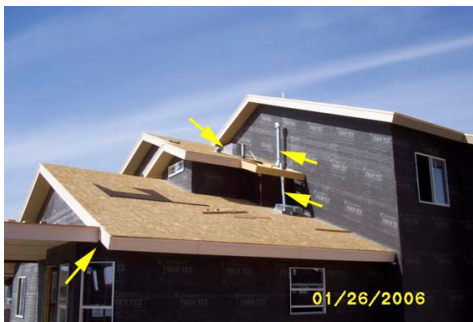
Looking @ south east corner of house – furnace and water heater flues too short and too close to vents and AC **7**

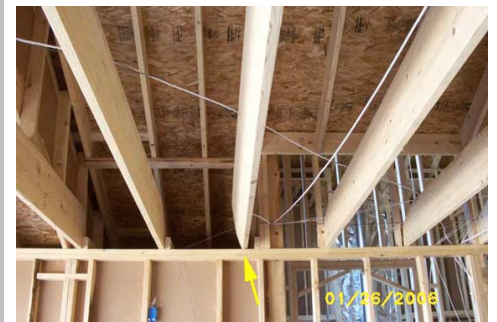
Looking east @ garage interior east side – note arrow points to severe twisting ceiling joist **9**

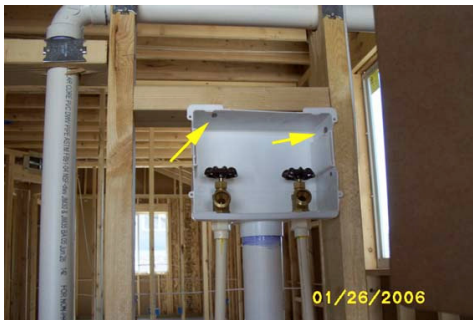
Looking @ washer hook up box – note nails used to anchor in place **10**

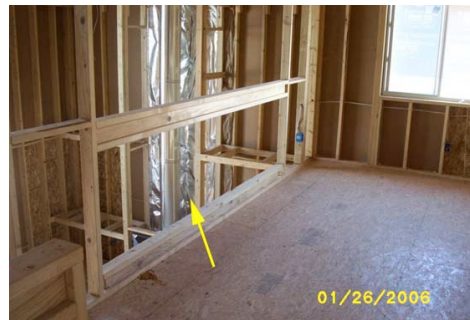
Looking @ railing in loft over looking living room – note no presence of vertical balusters **11**

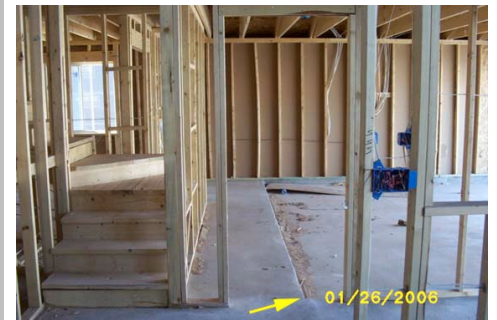
Looking @ door leading to garage – note garage step down bisects pathway in and out of door **12**
